**PRELIMINARY ASSESSMENT/  
VISUAL SITE INSPECTION**

**THE UNIVERSITY OF CHICAGO**

**CHICAGO, ILLINOIS**

**FINAL REPORT**

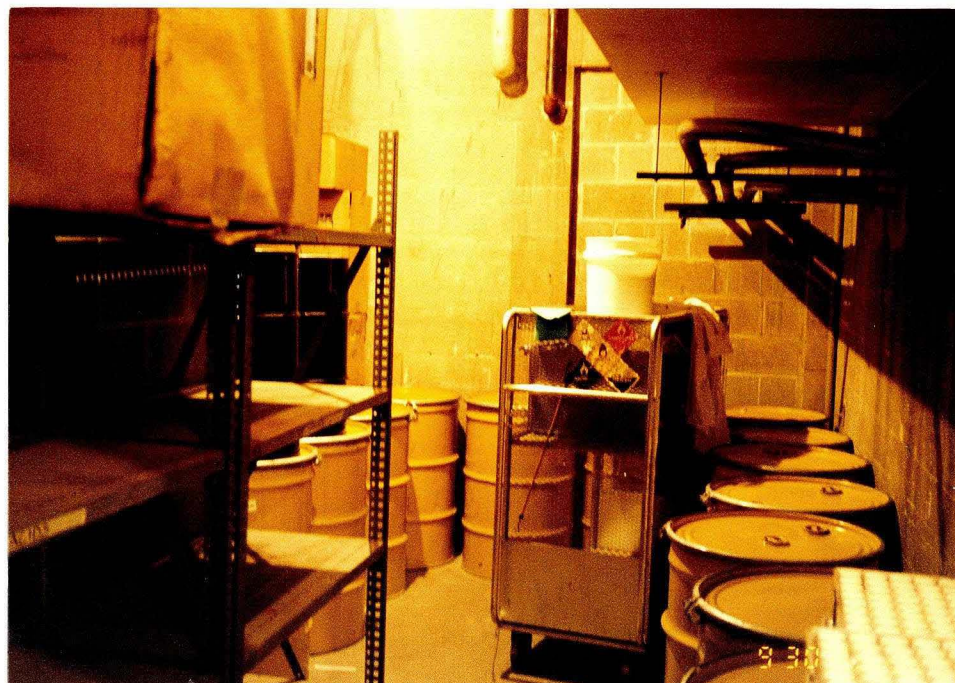
Photograph No. 1  
Orientation: North  
Description: Shelving units, overpack drums, and scintillation vials in waste chemical storage section of the FMI Blockhouse.

Location: SWMU 1

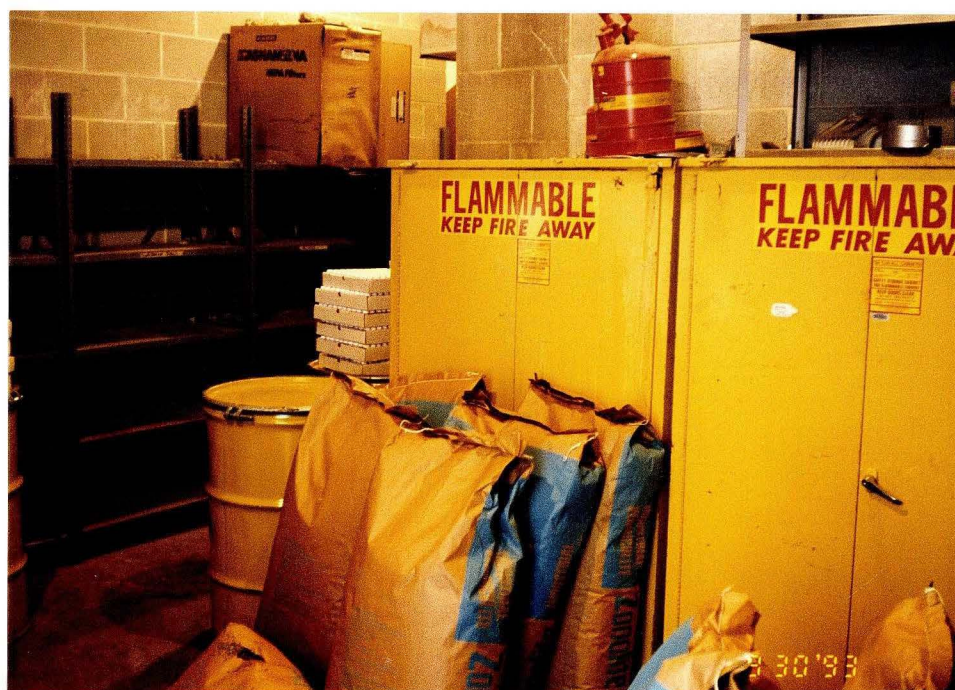
Photograph No. 2  
Orientation: North  
Description: Metal cabinets used to accumulate and store chemical hazardous wastes; note bags of vermiculite in foreground.

Location: SWMU 1

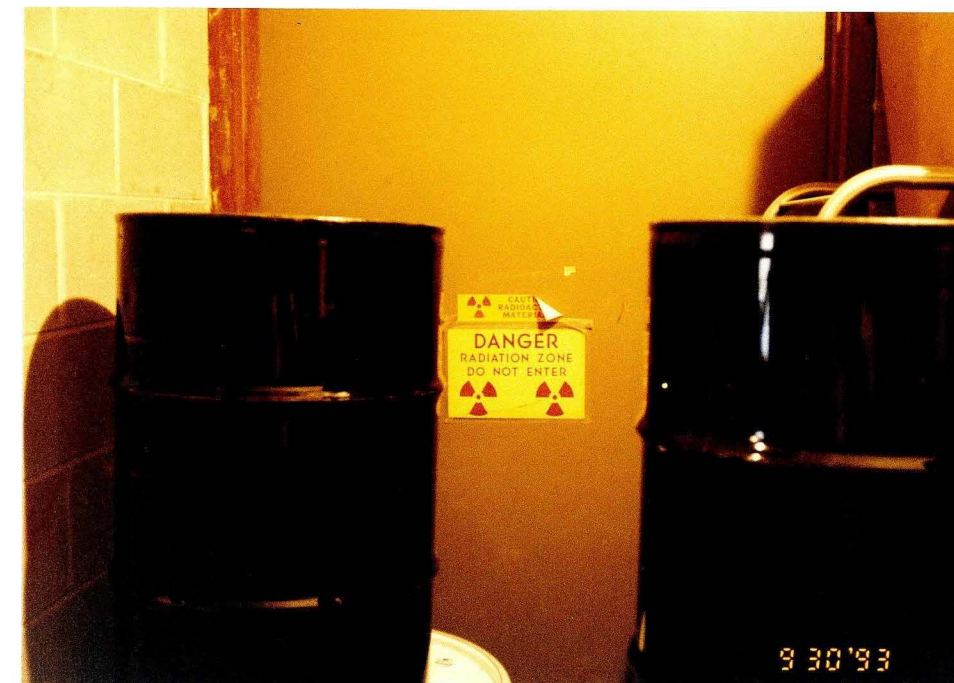
Photograph No. 3  
Orientation: West  
Description: Entrance to the low-level radioactive waste storage section of the FMI Blockhouse.

Location: SWMU 1

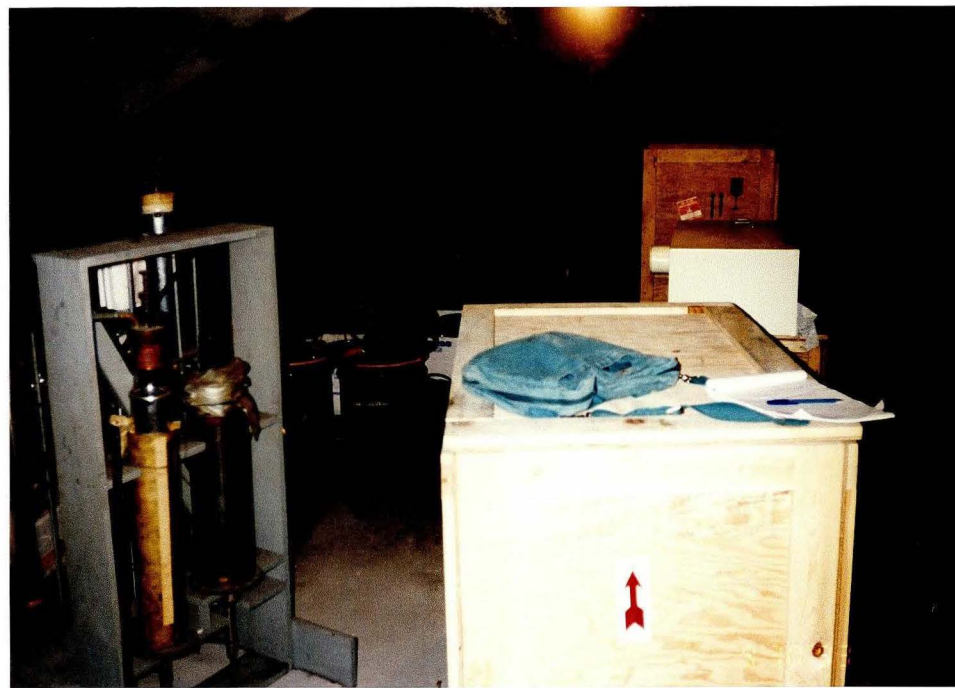
Photograph No. 5  
 Orientation: East  
 Location: SWMU 3  
 Date: September 30, 1993  
 Description: Former Accumulation Area No. 1 is currently used to store laboratory equipment and empty containers. PRC noted water was leaking from the ceiling, and the floor was chipped and worn.

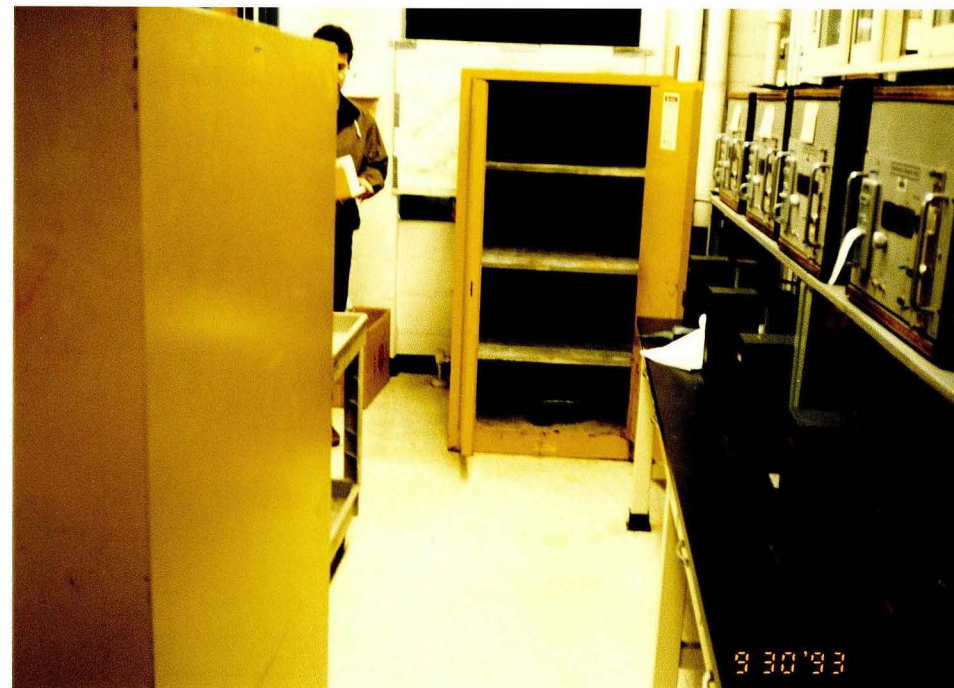
Photograph No. 6  
 Orientation: West  
 Location: SWMU 4  
 Date: September 30, 1993  
 Description: Storage cabinets for flammable chemicals were used to accumulate hazardous wastes at the Former Accumulation Area No. 2. Vermiculite seen on bottom shelf and in container on bottom shelf was used to absorb any spills.

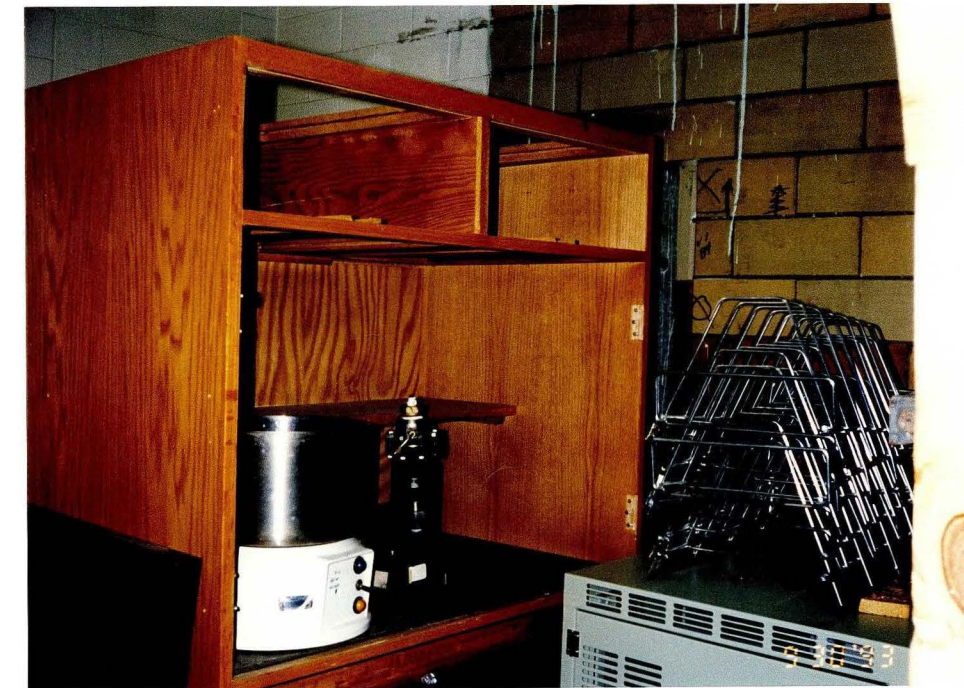
Photograph No. 7  
 Orientation: Northeast  
 Location: SWMU 5  
 Date: September 30, 1993  
 Description: Storage cabinets shown in Photograph No. 6 were previously located in the area shown in this photograph. Former Accumulation Area No. 3 is currently used to store furniture and laboratory equipment.

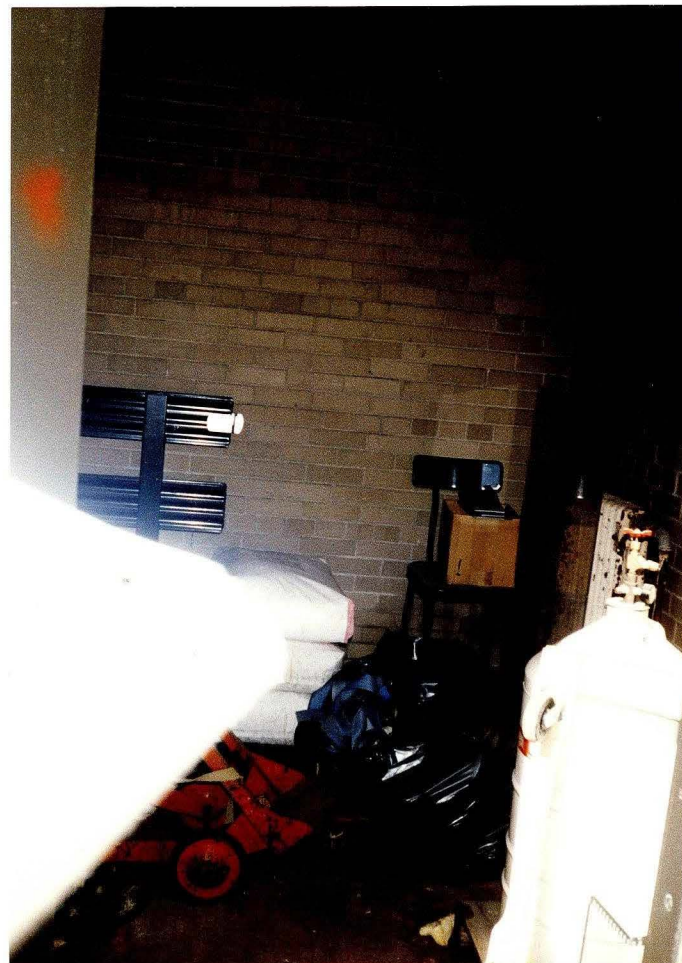
Photograph No. 8  
Orientation: North

Description: Hazardous wastes are no longer accumulated at the Former Research Institute Dock Accumulation Area. This unit is currently used to store various supplies. PRC noted no evidence of releases.

Location: SWMU 6  
Date: September 30, 1993

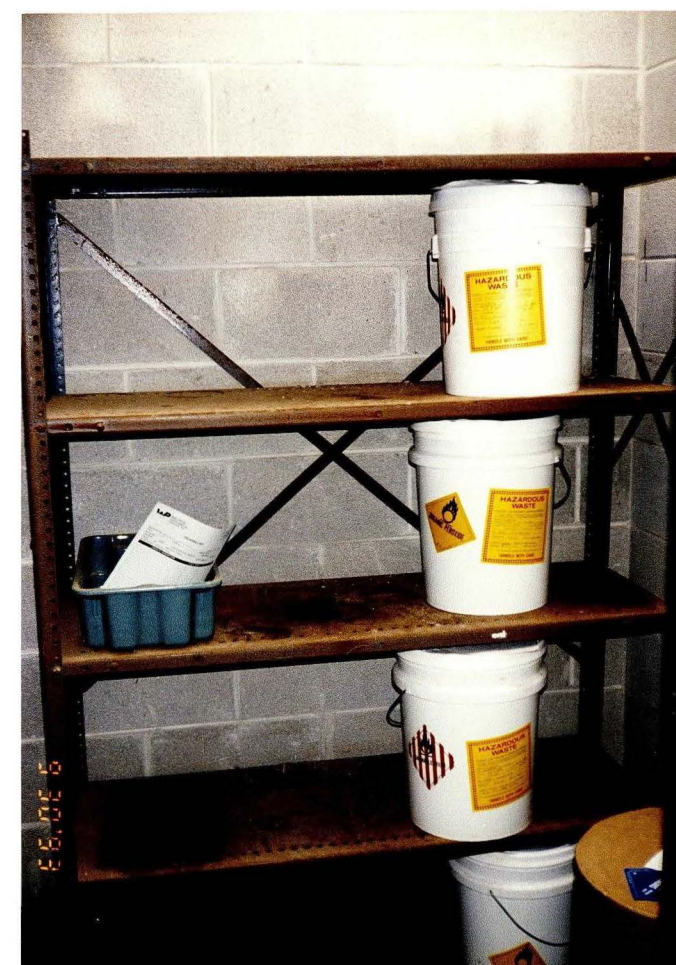
Photograph No. 11

Description: The following 20-gallon pails of hazardous waste were stored in the Laboratory Service Building reactive storage room: 20 gallons mixed waste (D001, D002, D003), 15 gallons of diuric acid (D001), and 15 gallons of flammable solids (D001). Additional miscellaneous waste chemicals were stored in their original containers. PRC noted no evidence of releases.

The reactive storage room included shelving with 20-gallon containers of waste, miscellaneous reactive waste materials in their original containers, and a container of nonregulated waste (see Photograph No. 11). Wastes included diuric acid (D001) and flammable solids (D001 and D003).

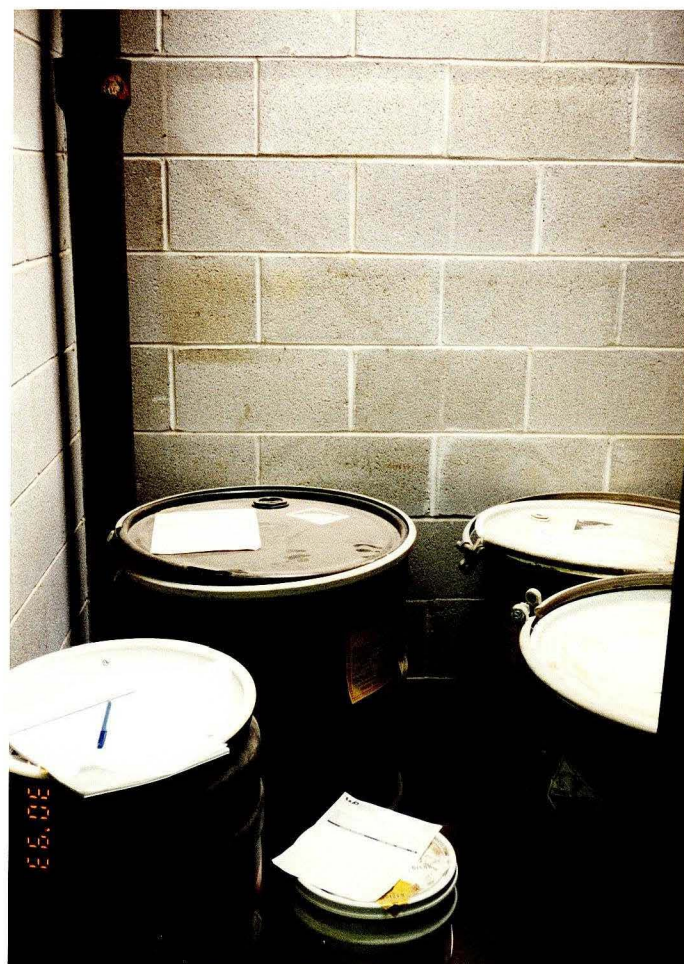
Photograph No. 12  
Orientation: South

Location: SWMU 9  
Date: September 30, 1993

Description: The following hazardous wastes were stored in the Laboratory Service Building corrosives storage room during the VSI: a 20-gallon container of acetic acid (D001, D002, D003), one 55-gallon drum of corrosive liquid (D001 and D002), one 55-gallon drum of waste corrosive liquid (D002), and one 55-gallon drum of sodium hydroxide (D001, D002, D0003, D004, and D005). PRC noted no evidence of releases.

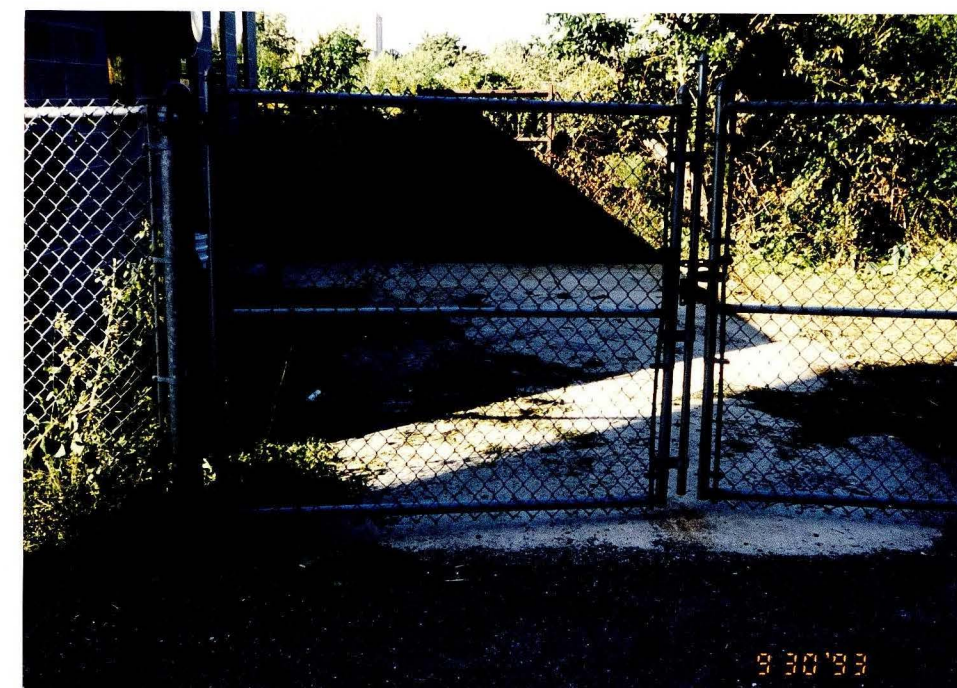
Photograph No. 14  
Orientation: North

Location: SWMU 9  
Date: September 30, 1993

Description: Empty concrete pad (part of SWMU 9) located at east end of the Laboratory Service Building; PRC noted no cracks or staining.

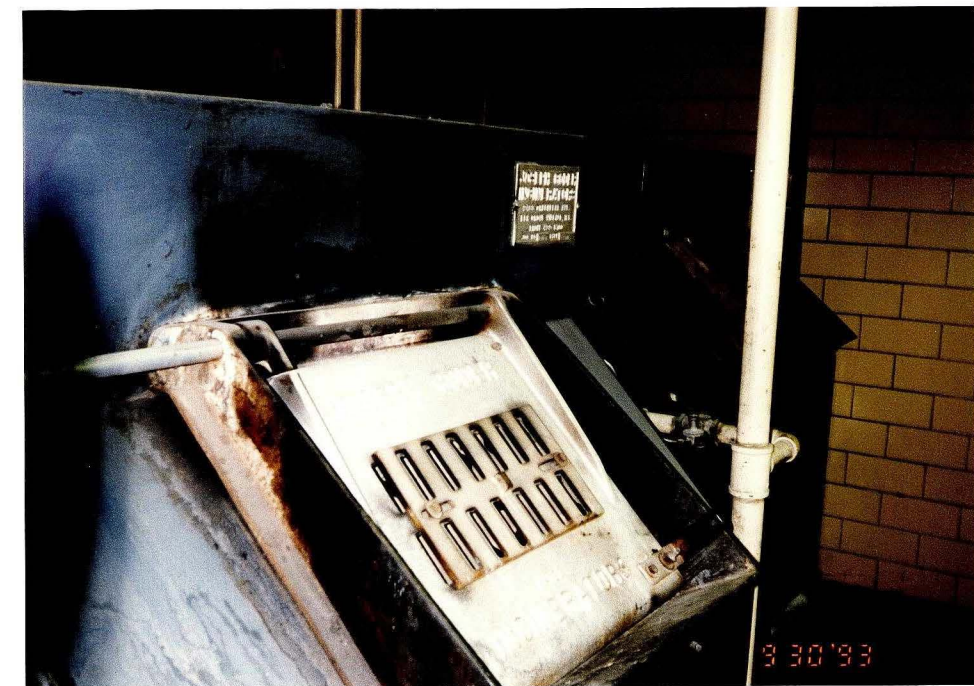
Photograph No. 17  
 Orientation: Northwest  
 Description: Twin burn units of the Anatomy Department Incinerator Area. Unit in background was not operational during the VSI.

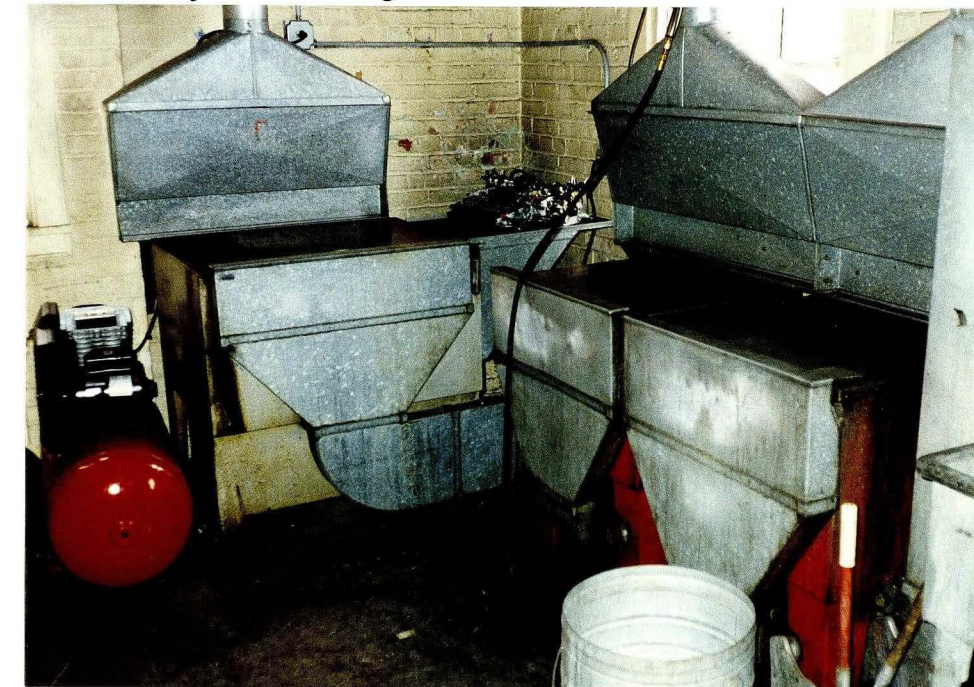
Finally, the Printing Service infrequently repairs typewriters. Typewriter parts are degreased in a series of covered tanks (see Photograph No. 18). Very infrequently, these tanks are drained and about 30 gallons of spent solvent (kerosene -- D001) is collected in a 55-gallon drum and transported to the Lab Service Building (SWMU 9).

Photograph No. 18  
 Orientation: Southeast  
 Description: Covered tanks used to degrease typewriter parts.

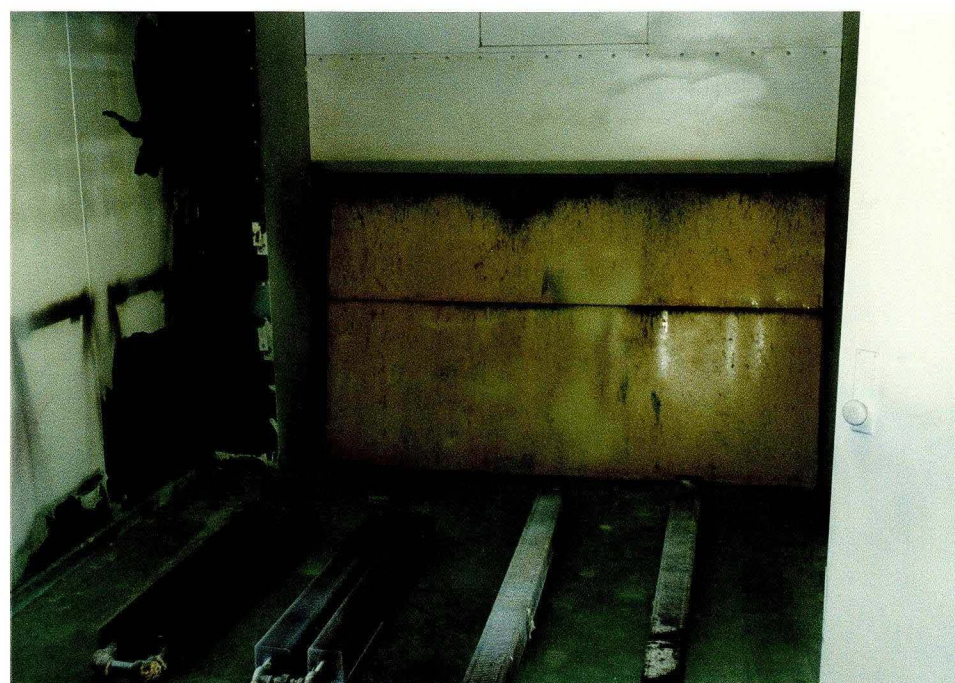
Photograph No. 21  
Orientation: West  
Description: The Paint Shop paint booth.

Location: SWMU 7  
Date: December 7, 1993

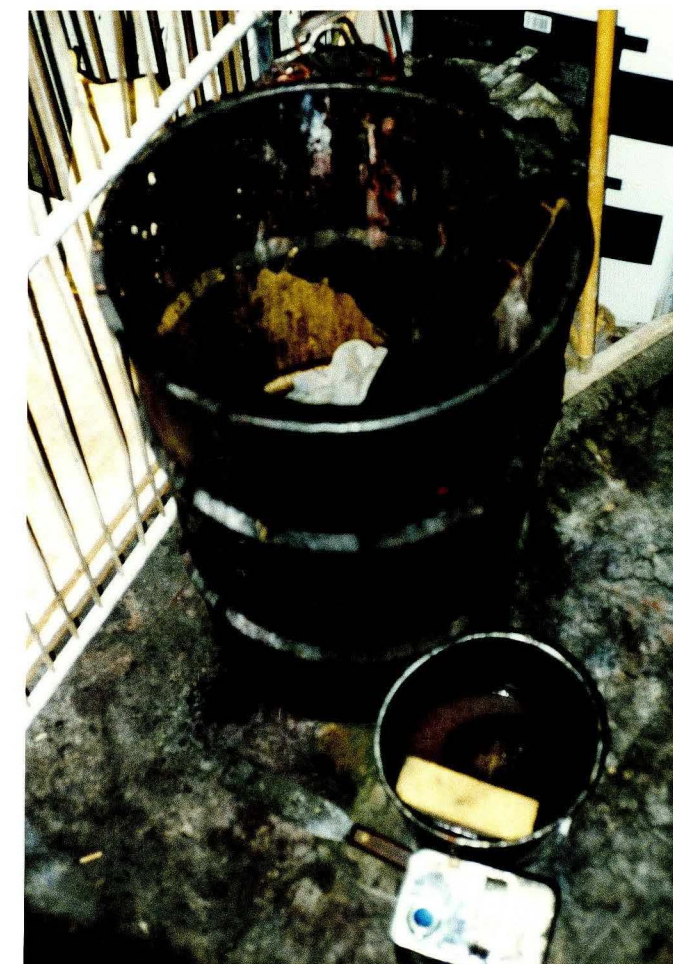
Photograph No. 23  
Orientation: North  
Description: The 55-gallon drum used to accumulate dirty cleaning rags. Some of the rags have absorbed waste solvents, waste solvent-based inks, and waste water-based inks. The 5-gallon bucket next to the drum may be used during cleaning of the printing equipment.

Location: SWMU 8  
Date: December 7, 1993

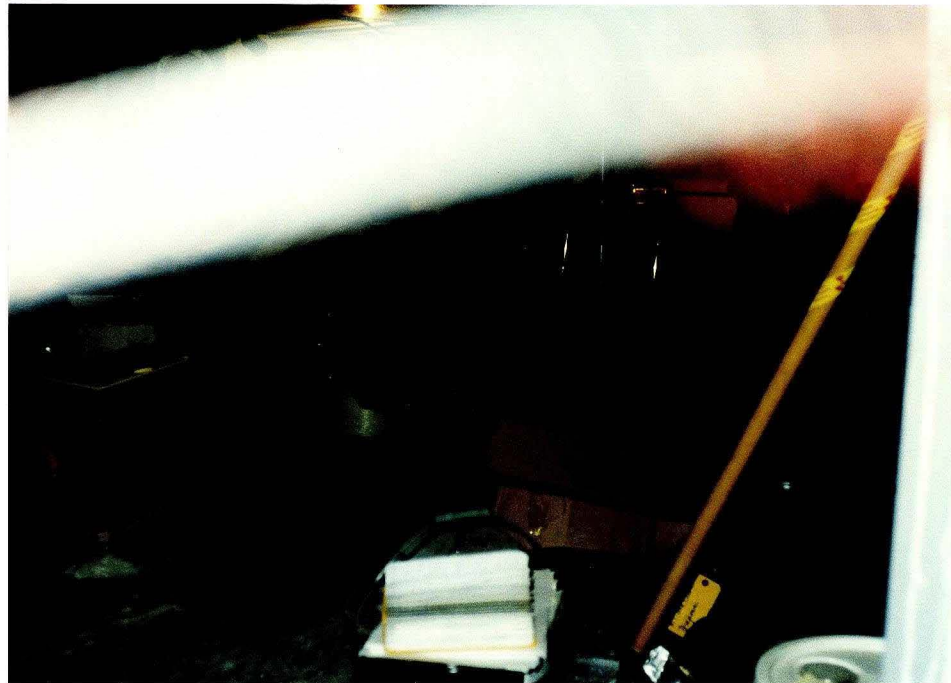
Photograph No. 25  
 Orientation: Southeast  
 Location: SWMU 10  
 Date: December 7, 1993  
 Description: Room No. IB-21 in the FMI. This room is currently used to store miscellaneous supplies and infrequently to store radioactive sources that UC hopes to find additional uses for.

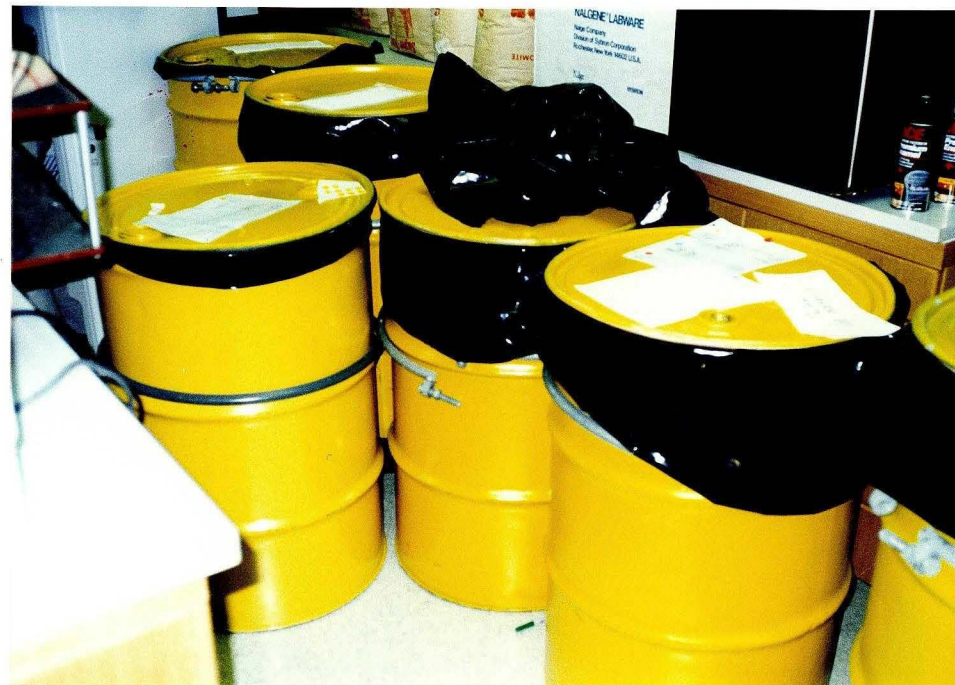
Photograph No. 26  
 Orientation: South-Southwest  
 Location: SWMU 11  
 Date: December 7, 1993  
 Description: The 55-gallon drums used to accumulate low-level radioactive wastes. These particular containers are located in Room No. N-220 in the Hughes Institute.

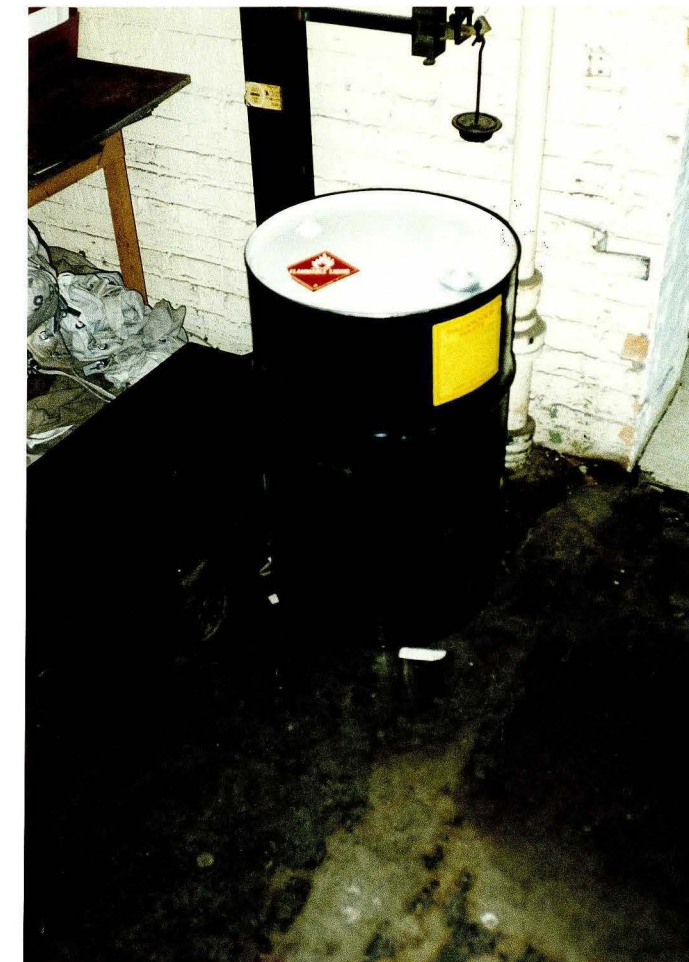
Photograph No. 24  
 Orientation: West  
 Location: SWMU 8  
 Date: December 7, 1993  
 Description: The 55-gallon drum that UC intends to begin using to accumulate waste water-based inks. The drum is labeled as containing D001 wastes.

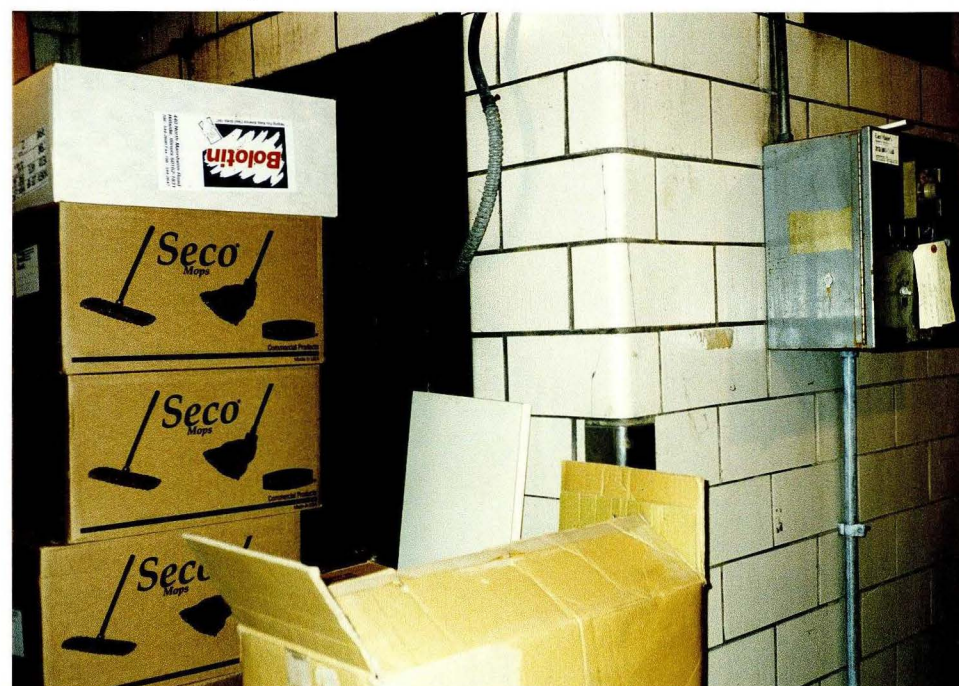
Photograph No. 28  
 Orientation: North-northeast  
 Description: The inactive CLI Hospital Incinerator Area located in Room No. L-048 in the CLI Hospital Building. The room is now being used to store miscellaneous supplies.  
 Location: SWMU 14  
 Date: December 7, 1993

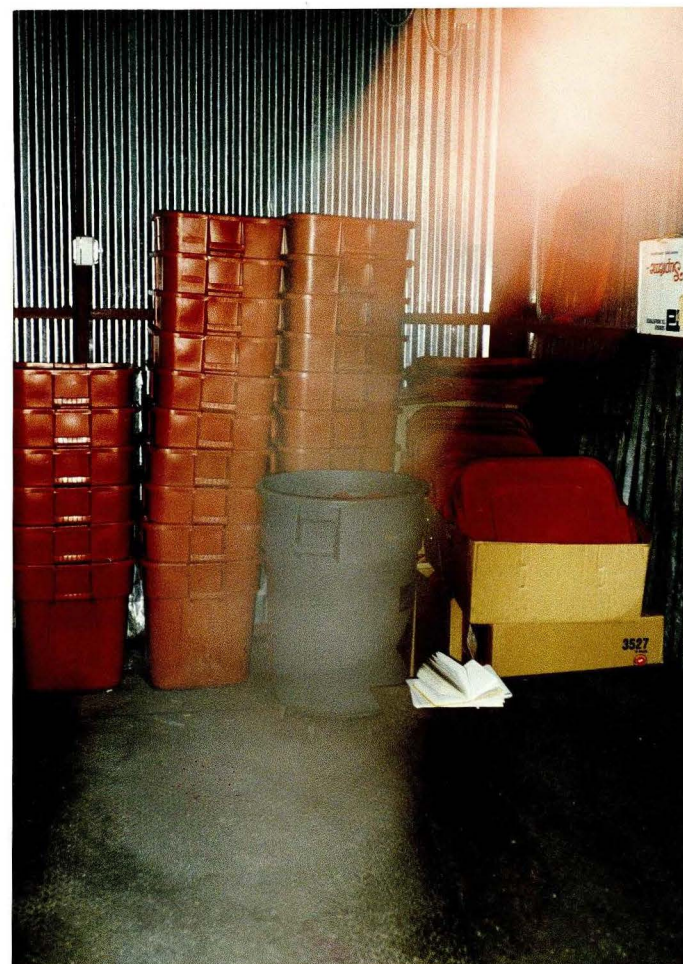
Photograph No. 30  
Orientation: North

Description: Closeup of the 8-gallon plastic containers used to containerize anatomical and chemotherapeutic wastes.

Location: SWMU 15  
Date: December 7, 1993

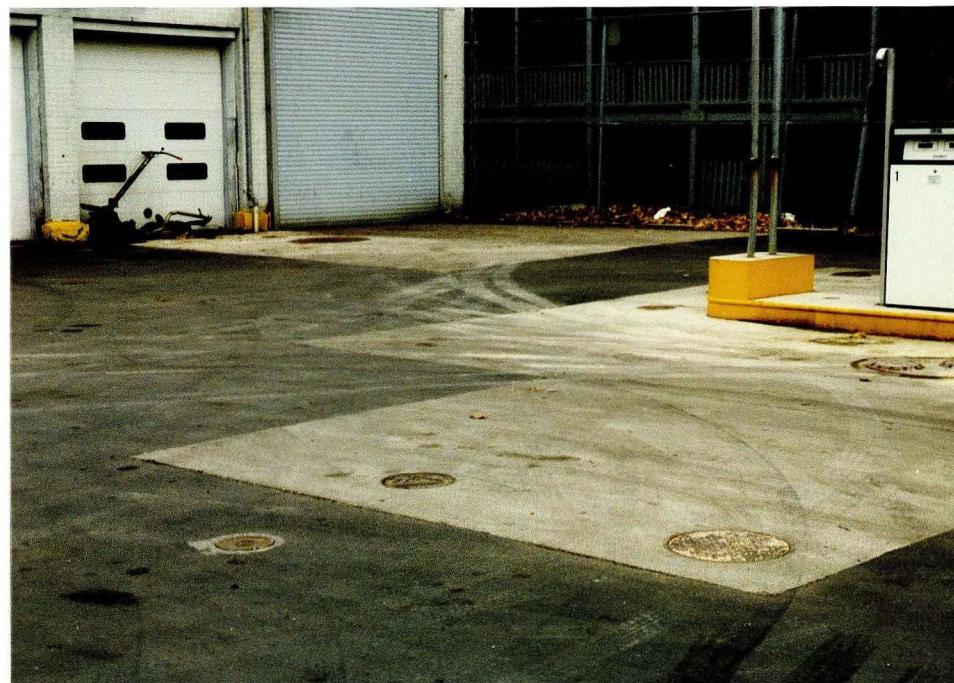
Photograph No. 33  
 Orientation: Southeast  
 Description: In the left rear of the photograph is visible the covered opening to the 500-gallon UST used to store waste oil generated from vehicle maintenance activities. In the foreground are visible covered openings to two of UCs USTs used to store diesel and gasoline, respectively (AOC 2).

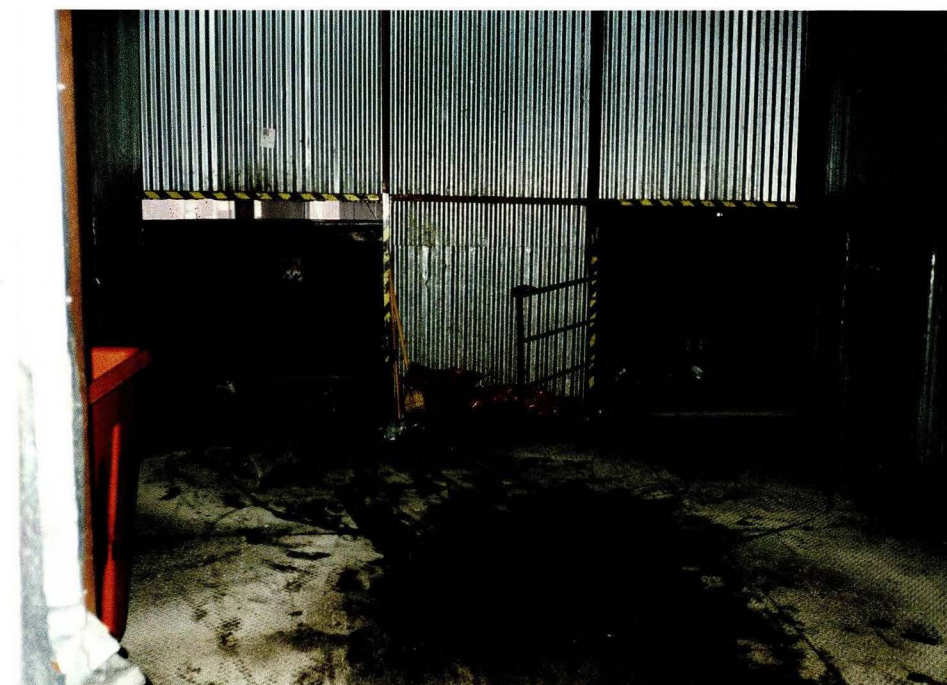
Photograph No. 32  
 Orientation: West  
 Description: The two compactors used to compact nonhazardous wastes such as paper and cardboard.

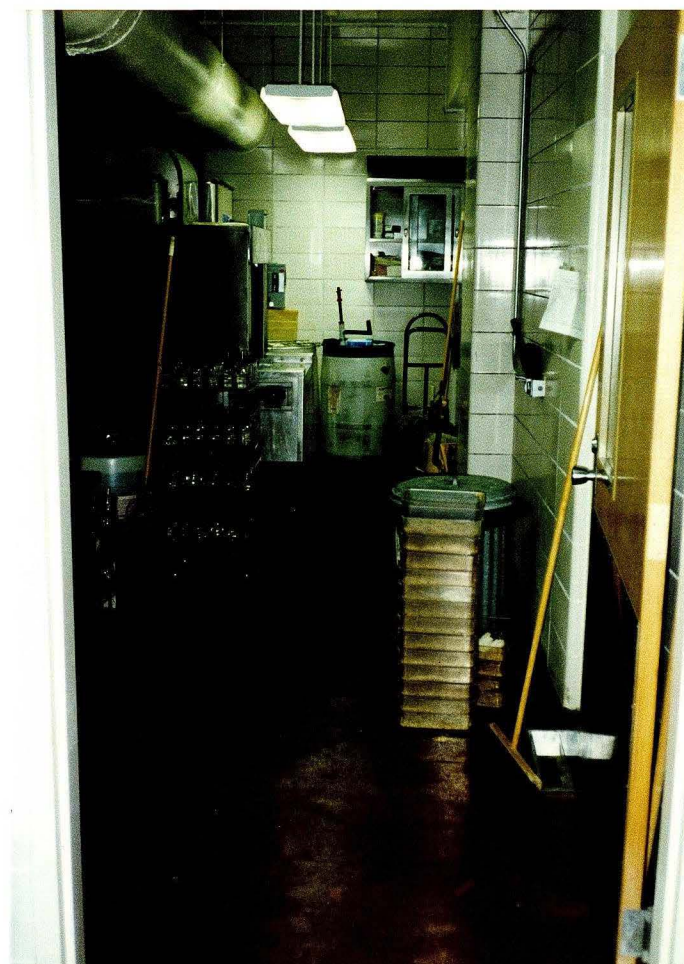
Photograph No. 35  
Orientation: South

Description: Location of the Former Wyler Hospital Incinerator Area. Room No. C-671 of the Wyler Hospital is now used to store an animal cage washer and other animal supplies. Trash can used to accumulate spent animal bedding is visible on the right side.

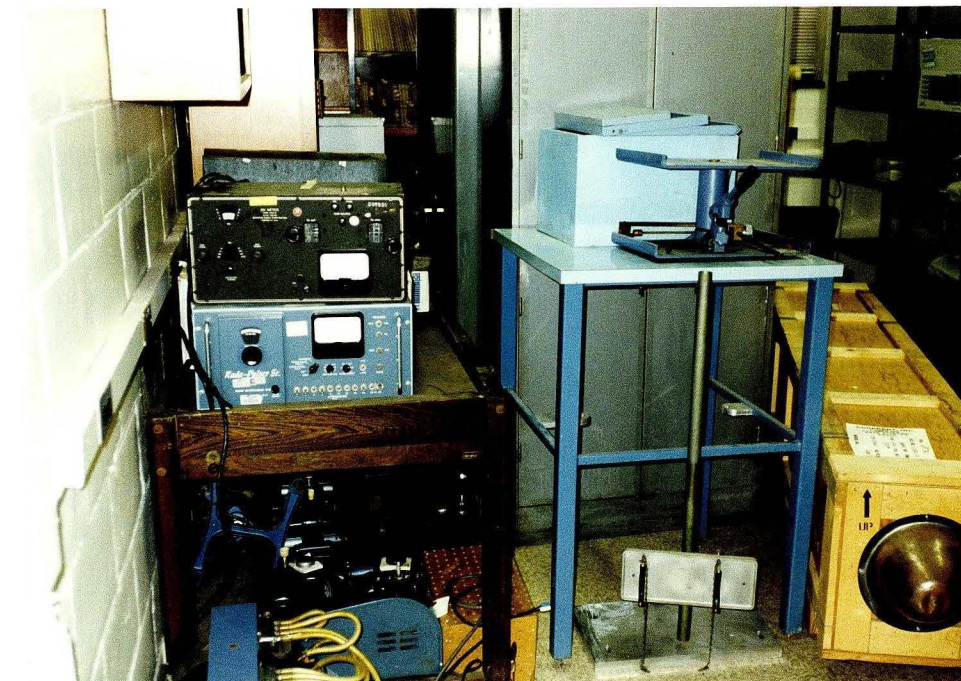
Photograph No. 36  
Orientation: East

Description: Location of the Former Accumulation Area No. 2. Room No. 401 of the Jones Laboratory Complex is now used to store miscellaneous electrical equipment and supplies.

**Unit Description:** This unit is Room No. 401 on the fourth floor of the Jones Laboratory Complex. The walls consist of cinderblocks and the floor is concrete. At least one (and maybe two) of the metal storage cabinets formerly located in Former Accumulation Area No. 1 (SWMU 3) were formerly located in this unit. The unit is now used to store miscellaneous electrical supplies (see Photograph No. 36).

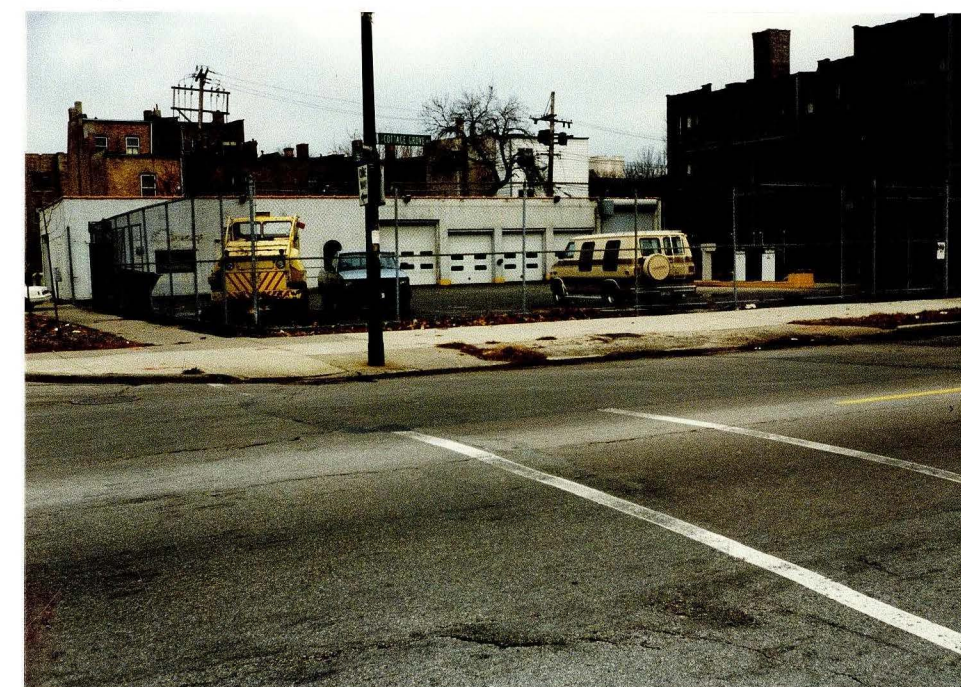
Photograph No. 37  
Orientation: East-southeast

Description: The LUST site located at UC's Physical Plant Department Motor Pool Facility at 5601 S. Cottage Grove.

The LUST (see Photograph No. 37) is currently undergoing site characterization (PRC 1993n). The Phase II Groundwater Investigation was completed at AOC 1 in February 1993 (UAS 1993); the investigation included collecting soil samples from 8 boring locations and groundwater samples from 7 monitoring wells. Soil and groundwater were found to be contaminated with BETX components and various PAHs (see Section 2.4 for a more complete discussion of the results). Two additional monitoring wells were installed sometime before December 7, 1993, and further remedial efforts (including preparation of a Corrective Action Workplan) have been proposed (UAS 1993).
